Manhole Inspection Summary

Manhole # S45A__023MH

Insp Date: **6/11/08 1:21 PM**

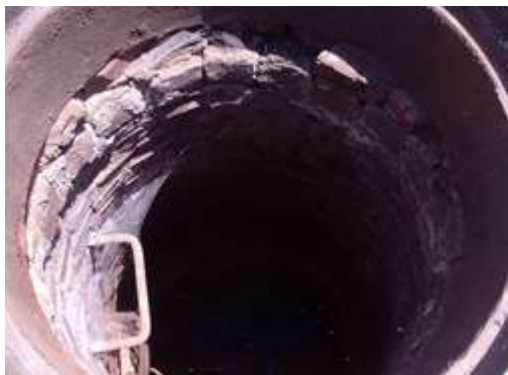
Defect 2

Condition: ☐ Sound ☐ Cracked ☐ Root Intrusion ☒ **Loose Brick** ☐ Deteriorated

Infiltration: ☐ None ☐ Joint ☐ Cracks ☒ **Mortar** ☐ Roots ☐ Wall

Loose Bricks

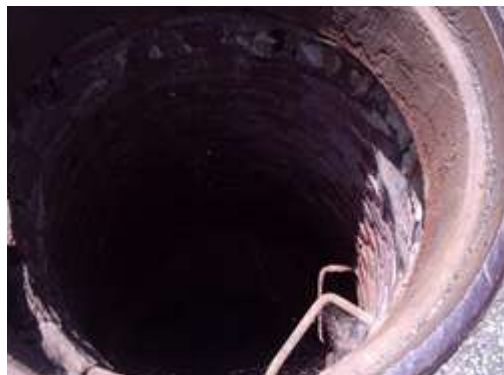
Defect 1

Adjustment Joint

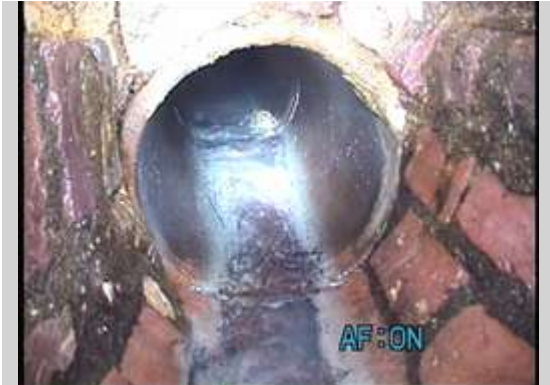
12 O'Clock Outflow

Pipe Height: **8.4** (in.) Rod and Bar (Angled)
Pipe Material: **Clay** ☐ Pipe Lined
Invert Depth: **11.75** (ft.) Flow Characteristics: **Fast**
Deposits: ☒ None ☐ Mud ☐ Sludge ☐ Debris ☐ Grease
Silt Depth: (in.) Deposits Extent:
Infiltration: **None** Pipe Seal Cond: **Sound**

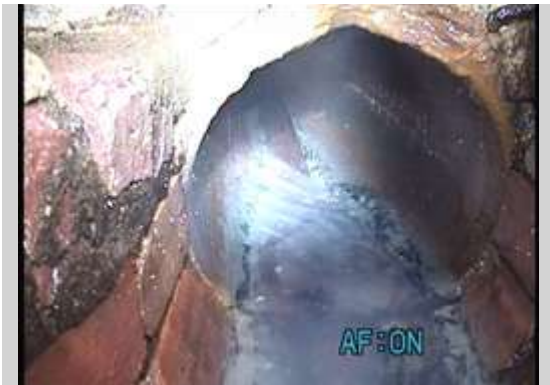
3 O'Clock Inflow

Pipe Height: **8.4** (in.) Rod and Bar (Angled)
Pipe Material: **Clay** ☐ Pipe Lined
Invert Depth: **11.65** (ft.) Flow Characteristics: **Fast**
Deposits: ☒ None ☐ Mud ☐ Sludge ☐ Debris ☐ Grease
Silt Depth: (in.) Deposits Extent:
Infiltration: **None** Pipe Seal Cond: **Sound**

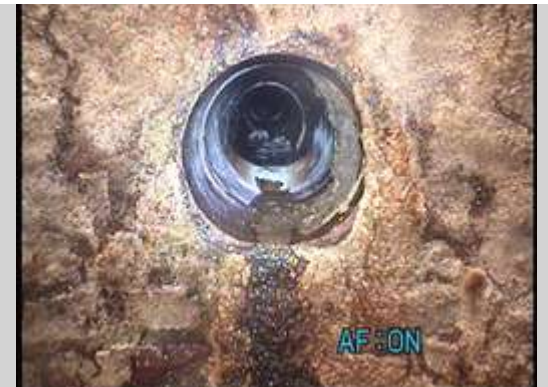
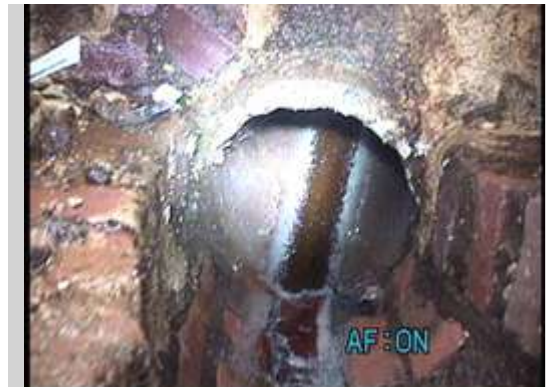
9 O'Clock Inflow

Infiltration: **None** Pipe Seal Cond: **Sound**

Drop: **Inside**

Drop Condition: **Open**
